Lummi Nation Silver Reef Casino Mitigation Project
Year 10 (2011) Monitoring Report
USACE Reference: 1999-4-01575

Prepared by:
Otak, Inc.
10230 NE Points Drive, Suite 400
Kirkland, WA 98033
Otak Project No. 30908D

November 30, 2011

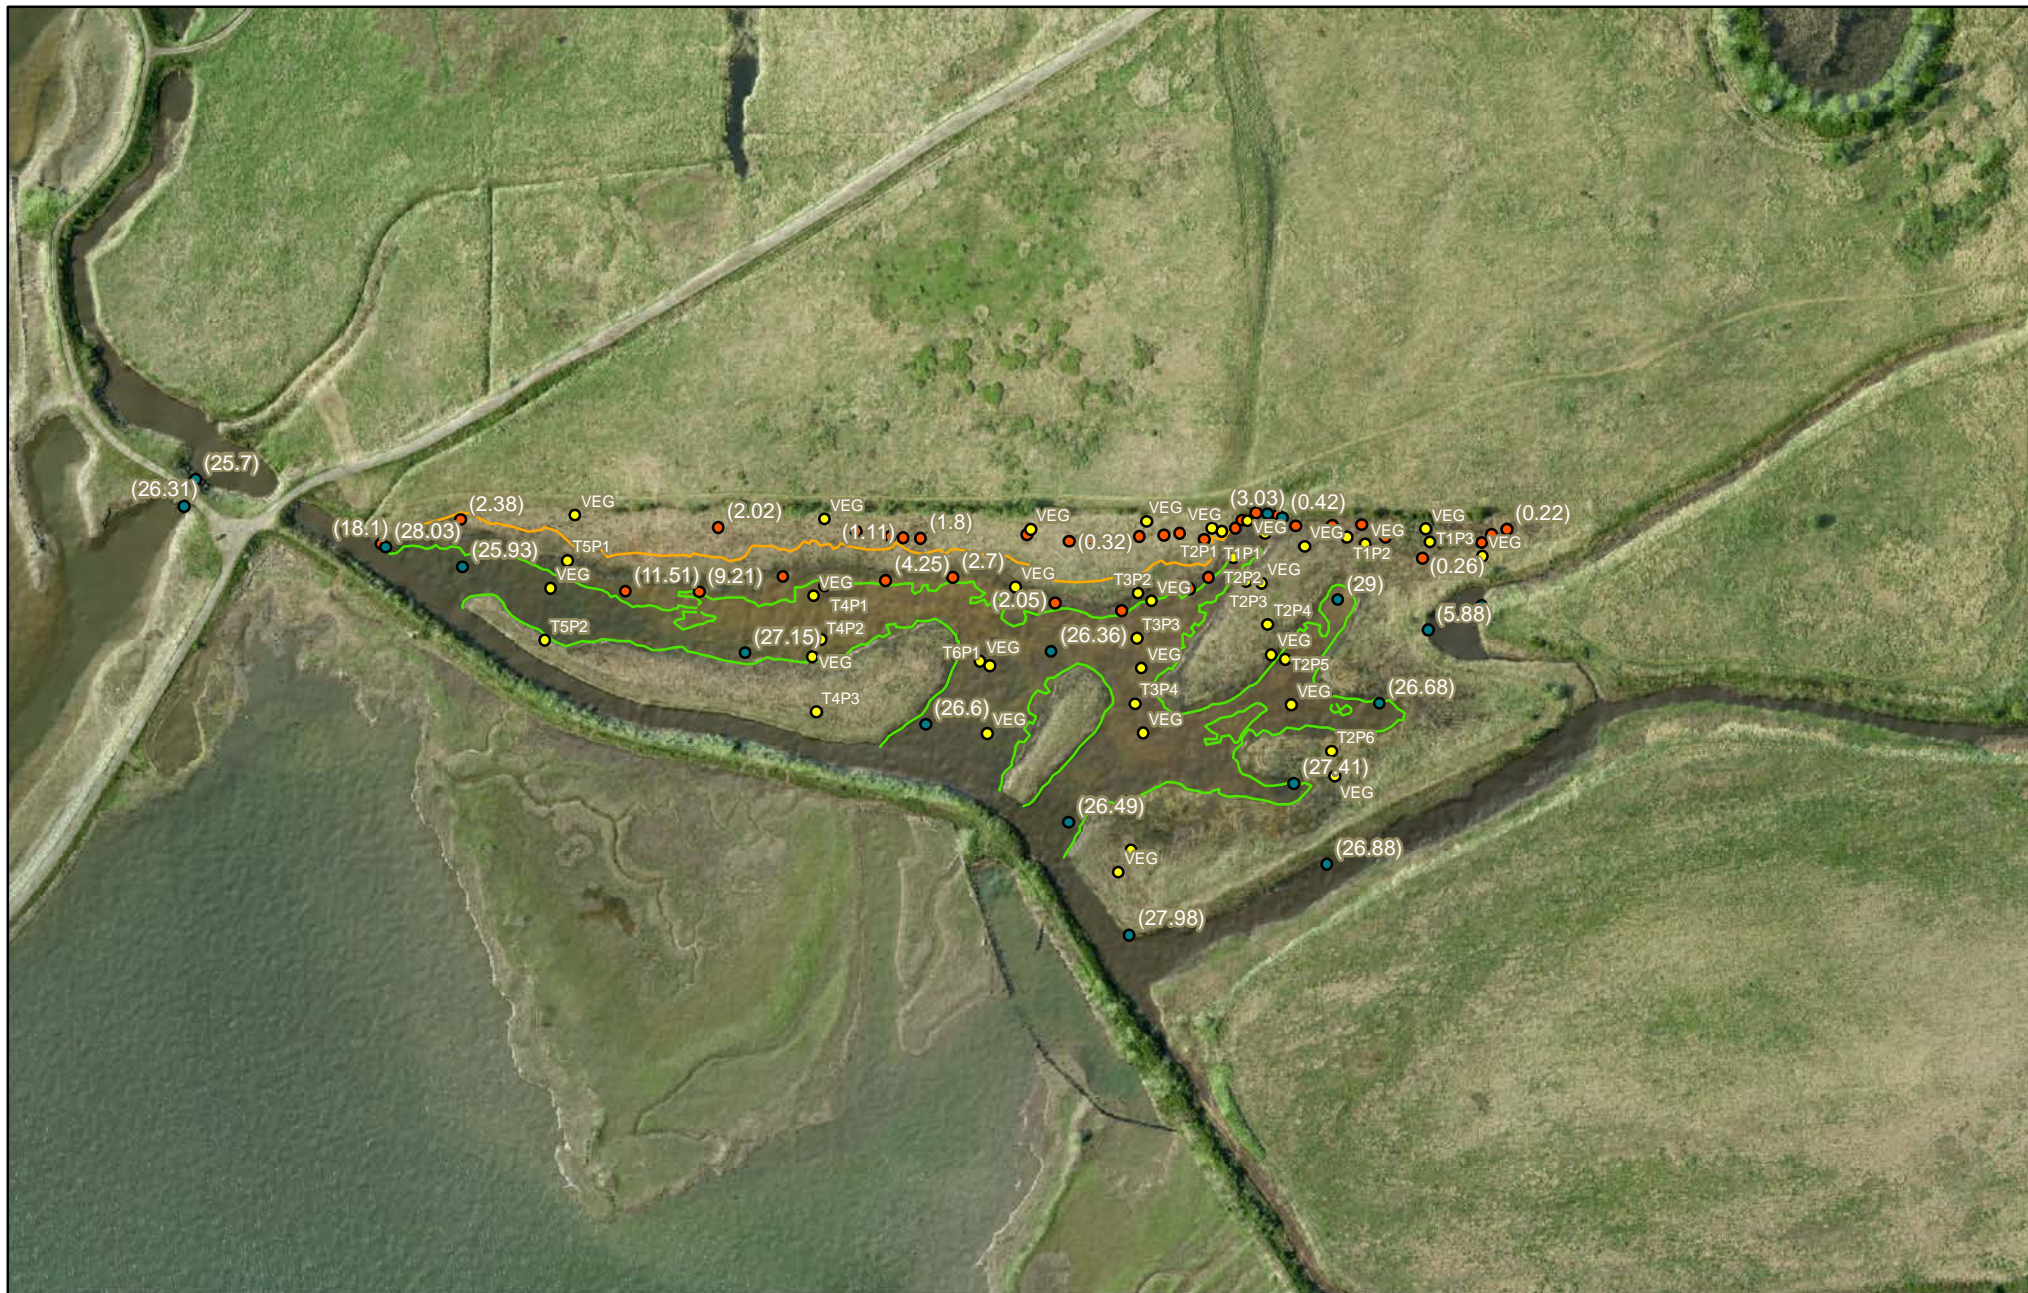
- Casino Mitigation Sampling Plots
- Salinity Sampling 07/13/2010 (*Salinity in ppt*)
- Salinity Sampling 06/18/2010
- Debris Waterline 02/22/ 2010
- Vegetation Boundary 07/31/2009

^a The Performance Standard of 5.0 ppt salinity was achieved on the majority of the mitigation site in the summer. Salinity concentrations on most of the remainder of the site were greater than 0.5 ppt, which is within the conventional limits of estuarine salinity – see Section 3 and Figure 2 in Appendix A for details.

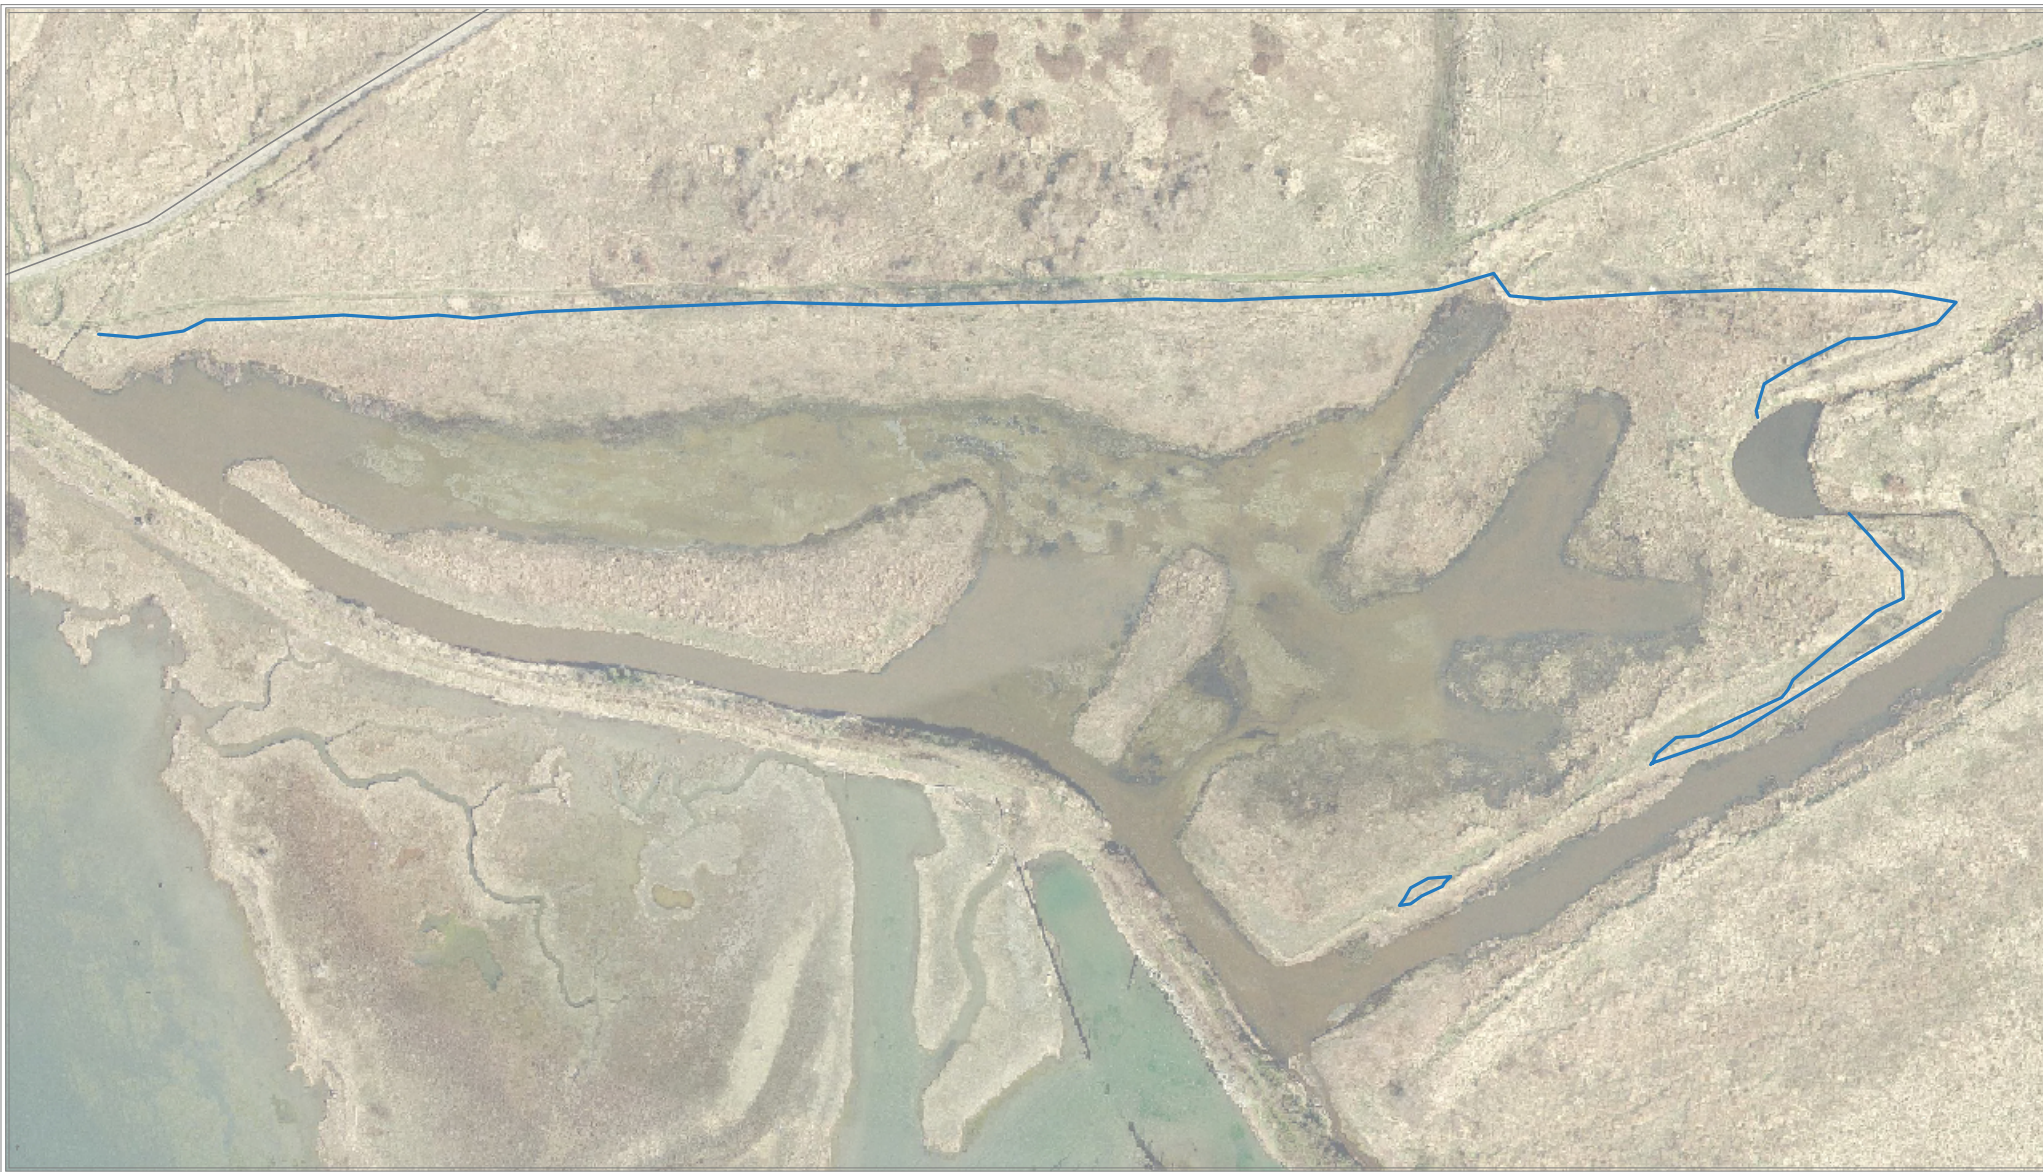
Casino Mitigation Site Inundation (12/21/2010)

The three required channel connections from the mitigation site to the slough were created when the site was constructed in 2001, and they are now well established (see Figures 1 through 6 in Appendix A). Water depths were measured in December 2010 and January 2011 (although water depths were only measured around the perimeter of the mitigation area), and the extent of inundation was mapped (see Figures 1 and 3 in Appendix A). Figure 3 shows that nearly the entire mitigation site was inundated in December 2010. The map of vegetation communities (see Figure 4 in Appendix A) and the wetland delineation report (Otak, 2011) demonstrate that approximately 18.1 acres of the approximately 18.7 acre site have sufficient hydroperiod for either hydrophytic vegetation or mud flats to become established; and that approximately 15.3 acres (or approximately 89 percent of the 17.1 acre mitigation area) is inundated frequently enough to establish high

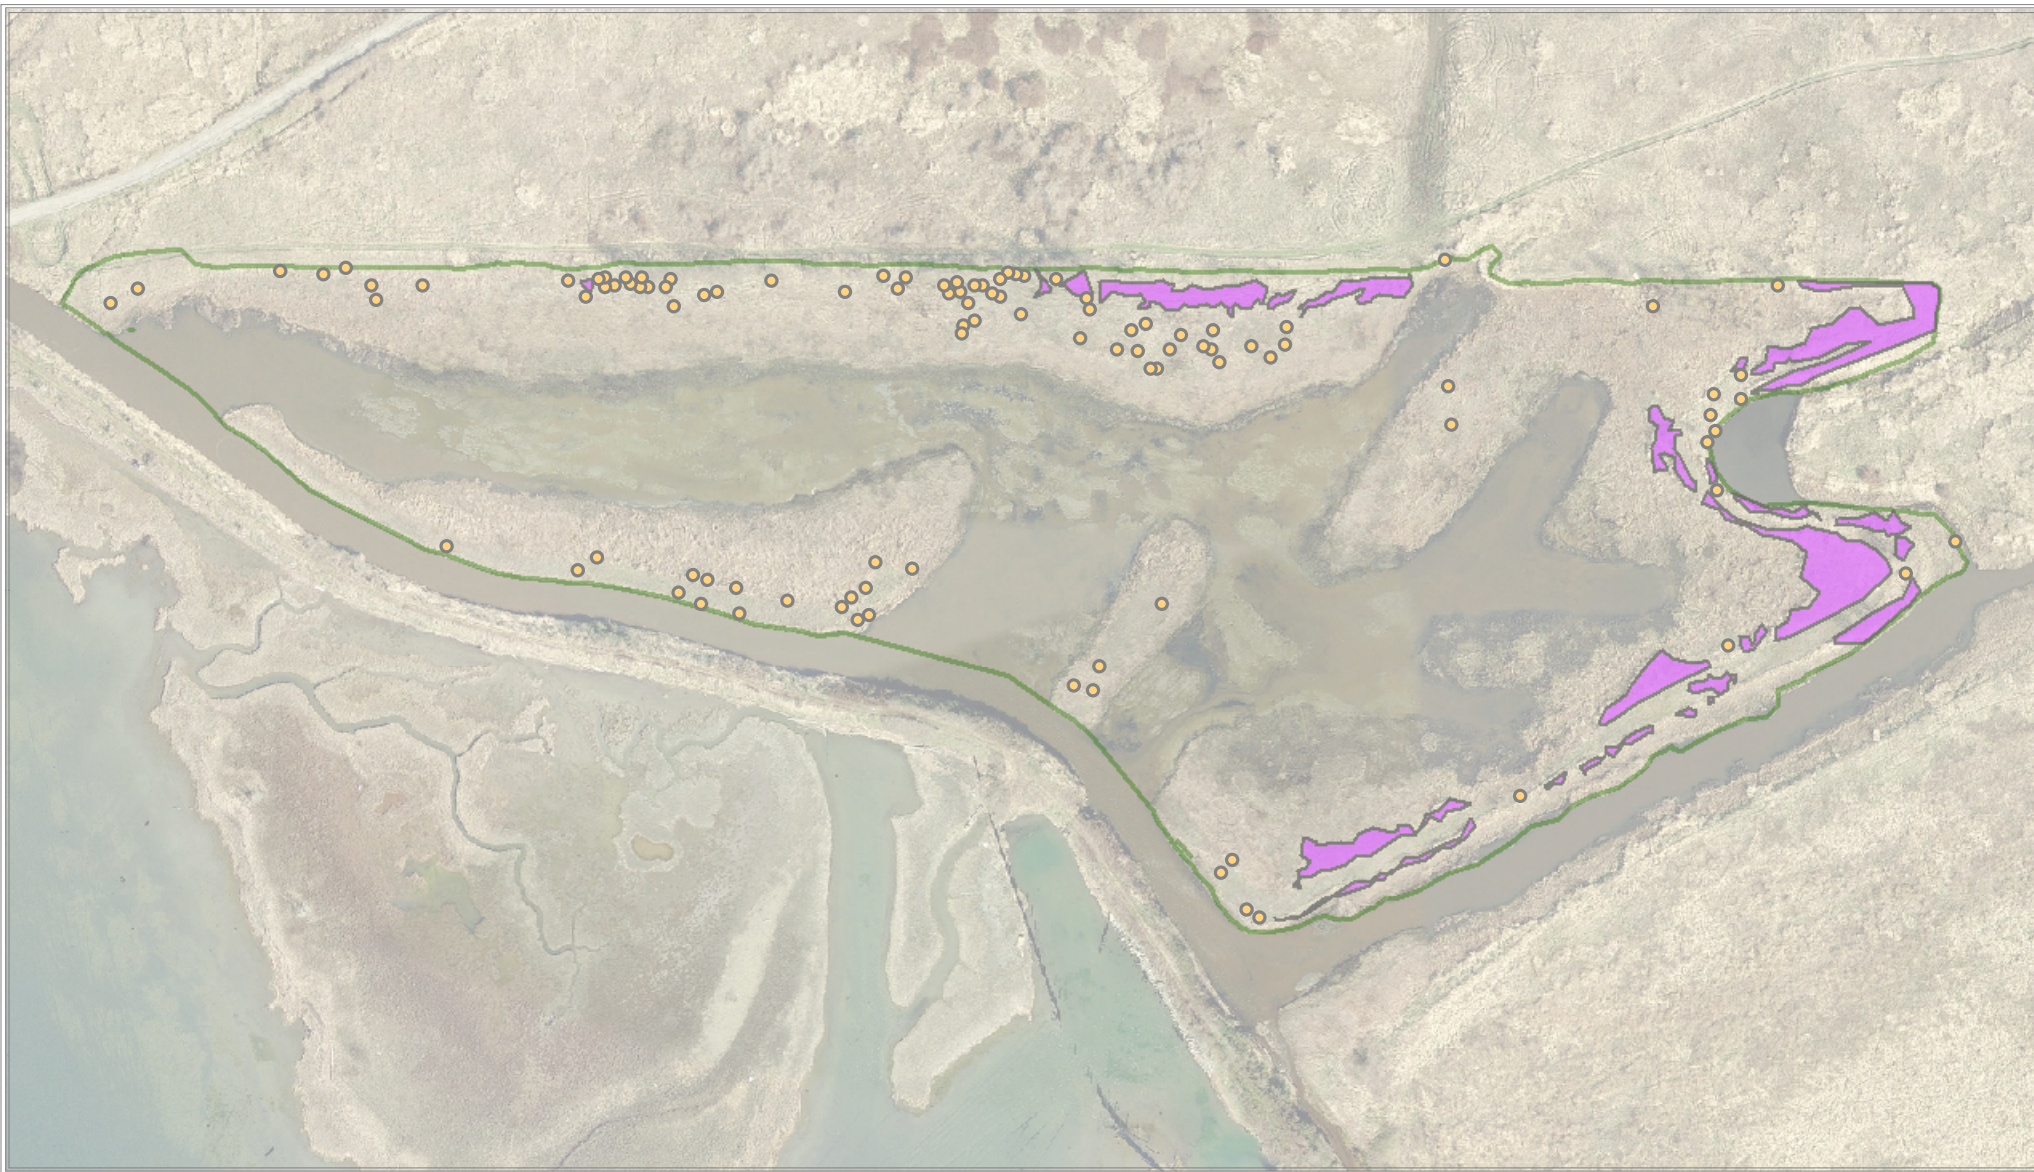
Casino Mitigation Site Invasive Plant Species (06/05/2011)

- Casino Mitigation Bank Project Boundary
- Area with Invasive Species
- Small Area of Invasive Species (<16 ft. sq.)

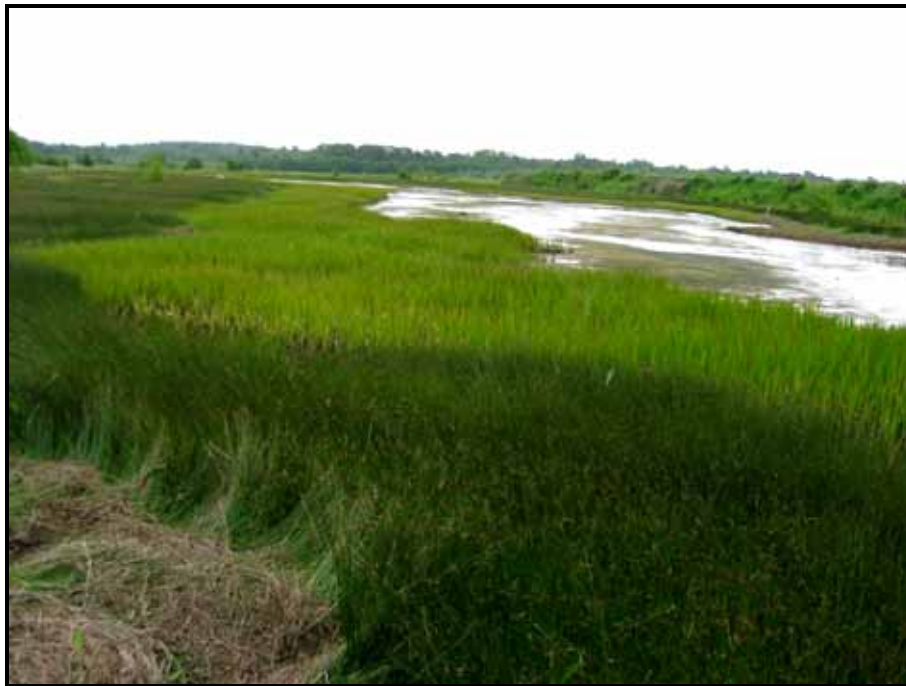
Photo 2—Overview of the mitigation site from the northwest corner, looking east/southeast on June 1, 2011. Note the transition from the high saltmarsh (dark green Baltic rush), to the low saltmarsh (lighter green alkali bulrush), to the mud flat

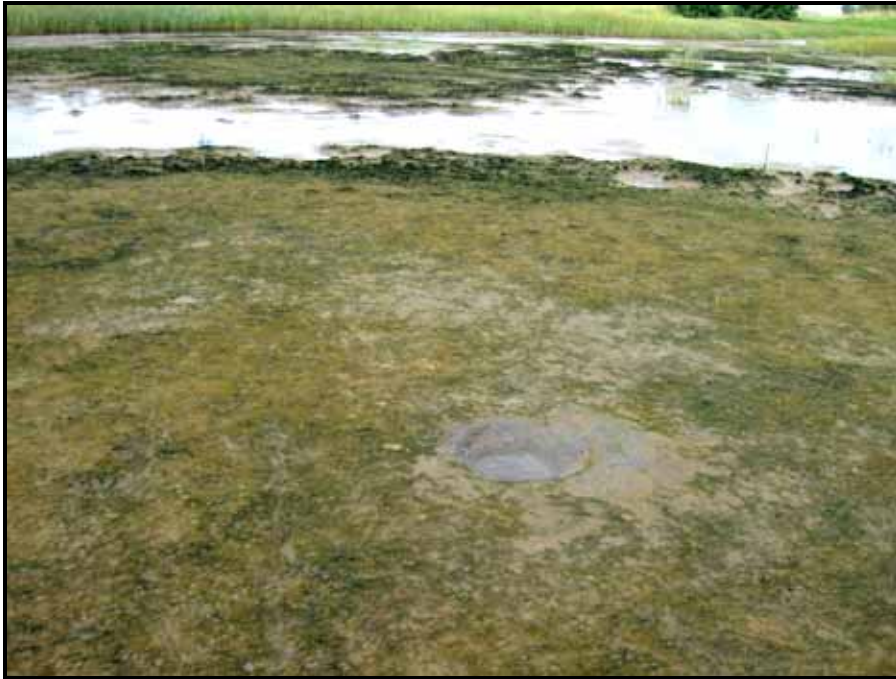
Photo 15—Transect 3, Plot 3, Looking North

Mud Flat: (see Photos 15, 16, 28, 32, and 33 in Appendix B)

- areas without macrophytic vegetation – includes many areas with filamentous green algae.

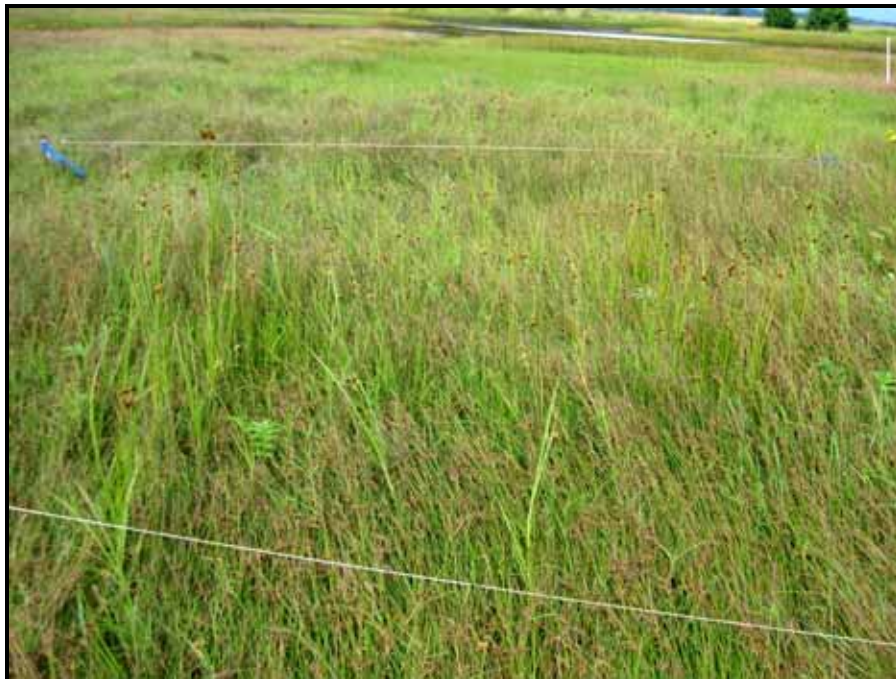
Photo 18—Transect 3, Plot 6, Looking North

High Marsh (mixed Baltic rush/Pacific silverweed community): (see Photo 18 in Appendix B)

- Baltic rush (*Juncus balticus*)
- Pacific silverweed (*Potentilla anserina* now called *Argentina anserina*)
- Lyngby's sedge (*Carex lyngbyei*) (subdominant)
- salt-grass (*Distichlis spicata*) (subdominant)
- creeping bentgrass (*Agrostis stolonifera*) (subdominant)

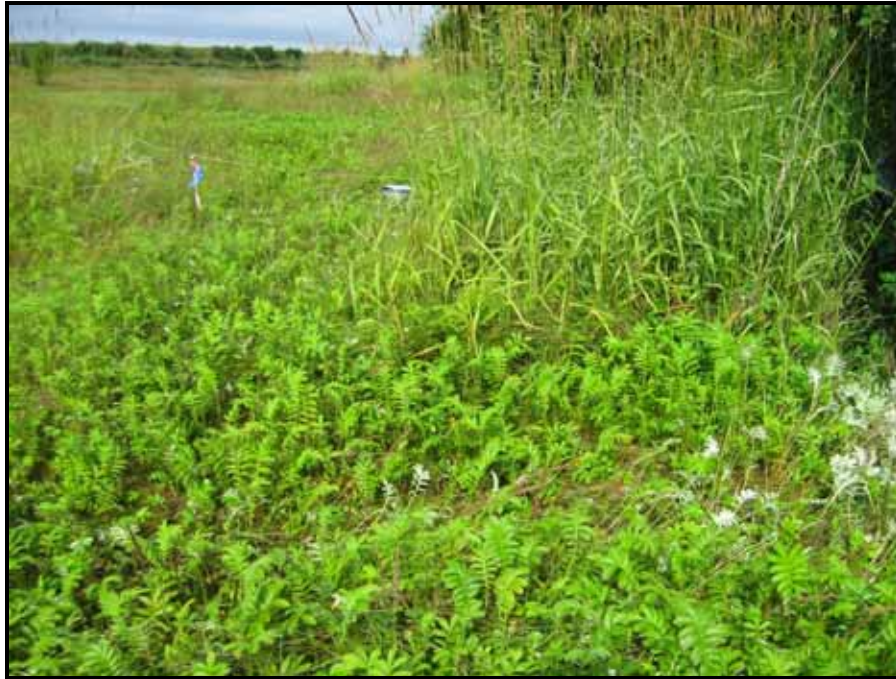
Photo 19—Transect 4, Plot 1, Looking West

High Marsh (Pacific silverweed/creeping bentgrass community): (see Photo 19 in Appendix B)

- Pacific silverweed (*Potentilla anserina* now called *Argentina anserina*)
- creeping bentgrass (*Agrostis stolonifera*)
- Baltic rush (*Juncus balticus*) (subdominant)

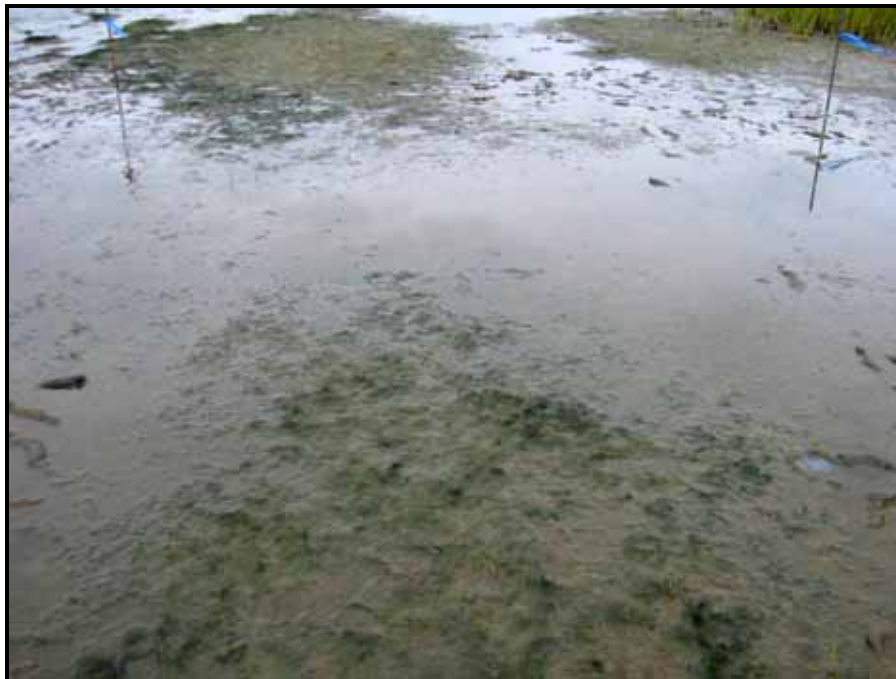
Photo 20—Transect 4, Plot 2, Looking West

Vegetated Mud Flat: (see Photo 20 in Appendix B)

- areas dominated by the aquatic species widgeongrass (*Ruppia maritima*).

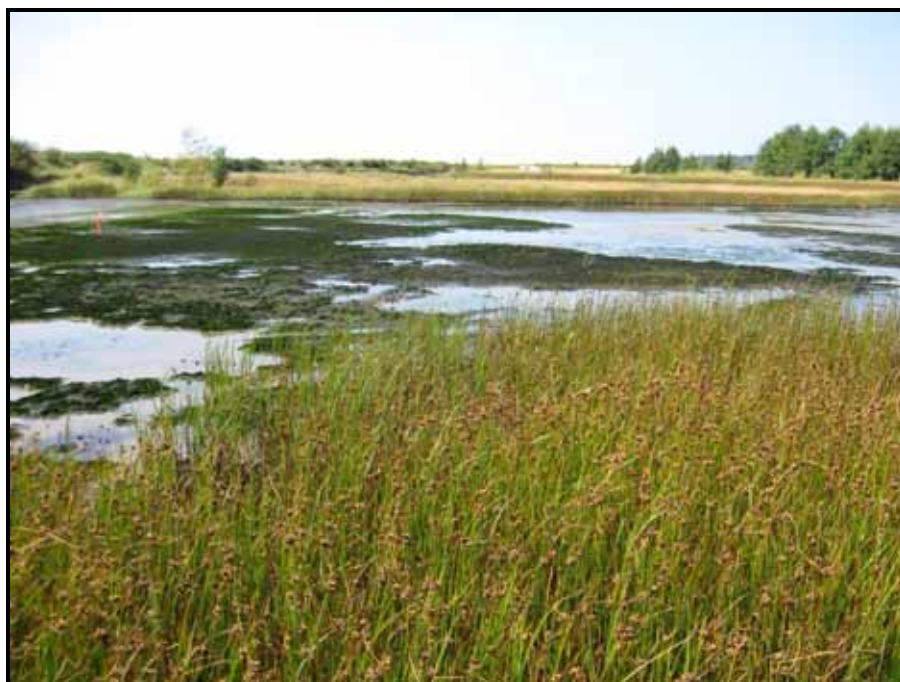
Low Marsh (alkali bulrush/pickleweed community): (see Photos 28, 29, and 30 in Appendix B)

Photo 28—Looking west perpendicular to Transect 6 at low saltmarsh alkali bulrush community and vegetated mud flat at half-tide

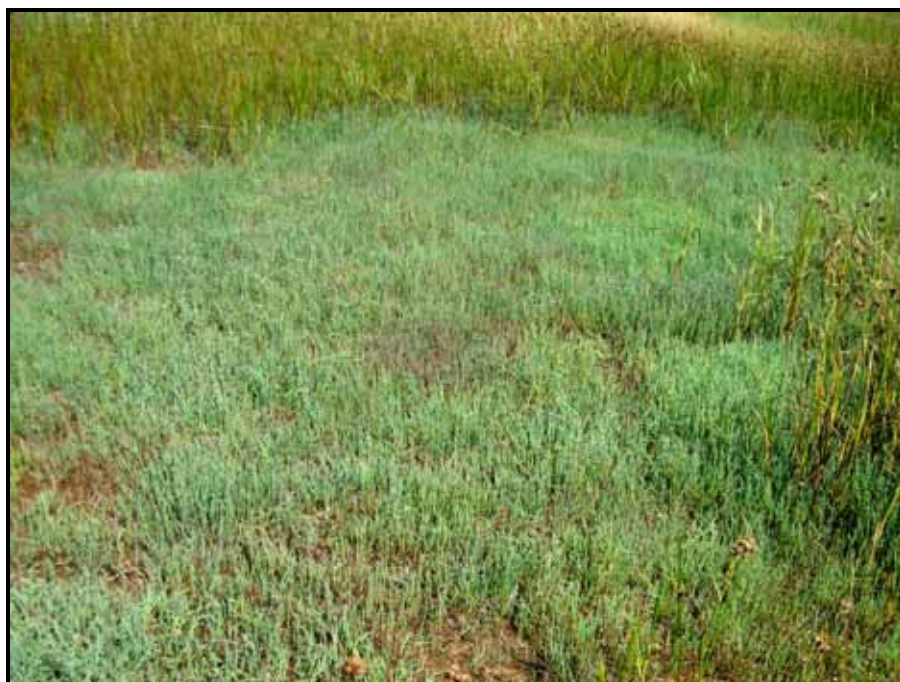
- alkali bulrush (*Scirpus maritimus*)
- pickleweed (*Salicornia virginica*)
- salt-grass (*Distichlis spicata*) (subdominant)

Photo 29—Low saltmarsh alkali bulrush/pickleweed community

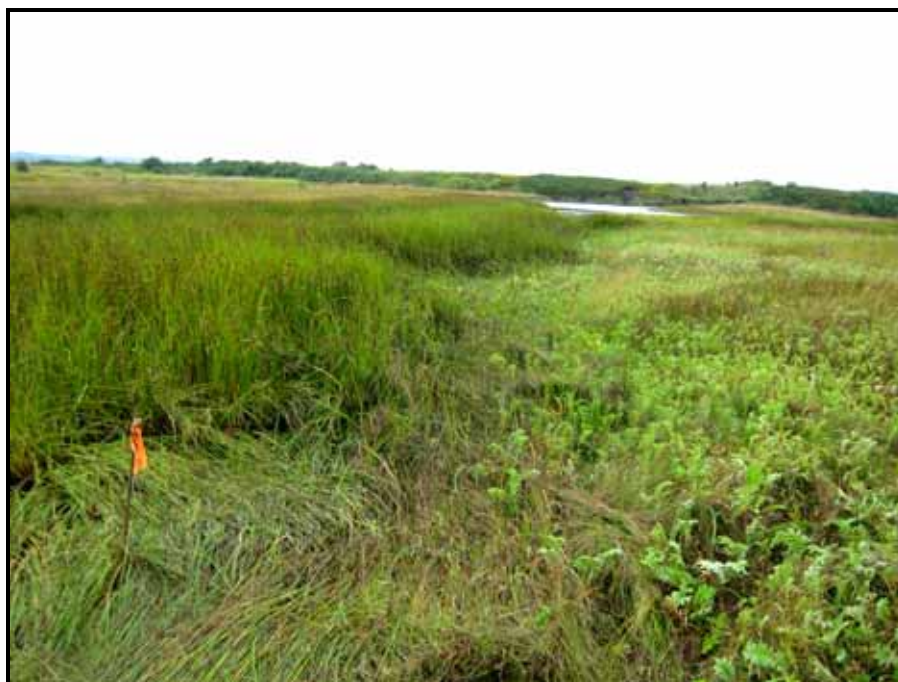
High Marsh (Baltic rush/Pacific silverweed community): (see Photos 30 and 31 in Appendix B)

Photo 30—Looking at transition from low saltmarsh alkali bulrush community on left, to high saltmarsh Baltic rush/Pacific silverweed community on right

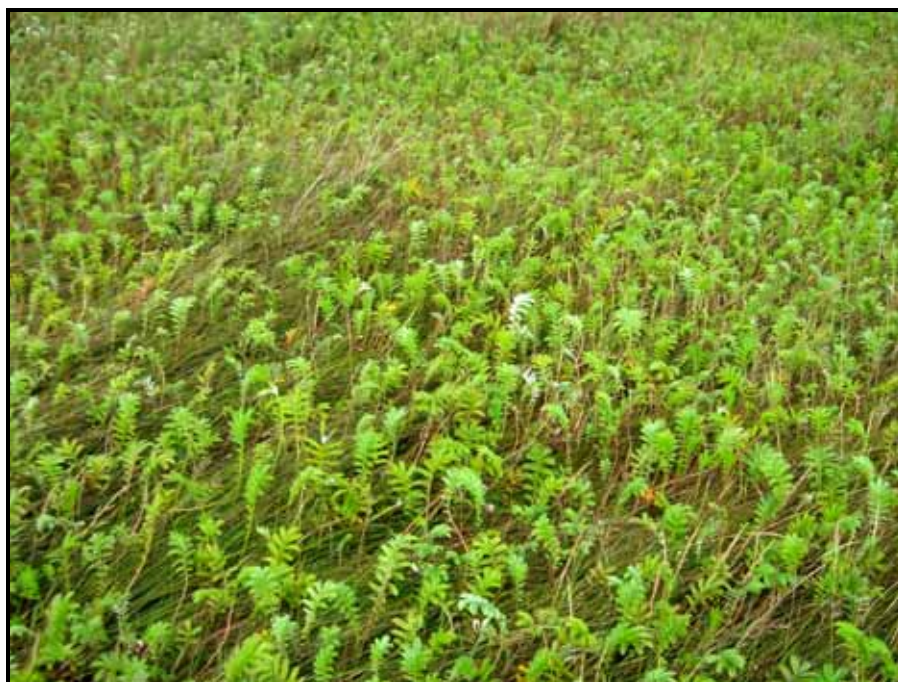
- Baltic rush (*Juncus balticus*)
- Pacific silverweed (*Potentilla anserina* now called *Argentina anserina*)

Photo 31— High saltmarsh Baltic rush/Pacific silverweed community

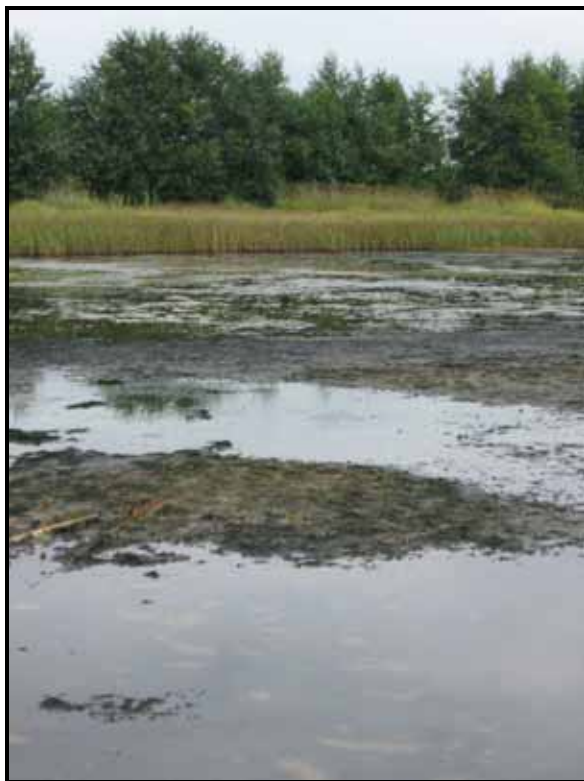
Photo 32—Looking north across mud flat at alders along northern boundary of mitigation site

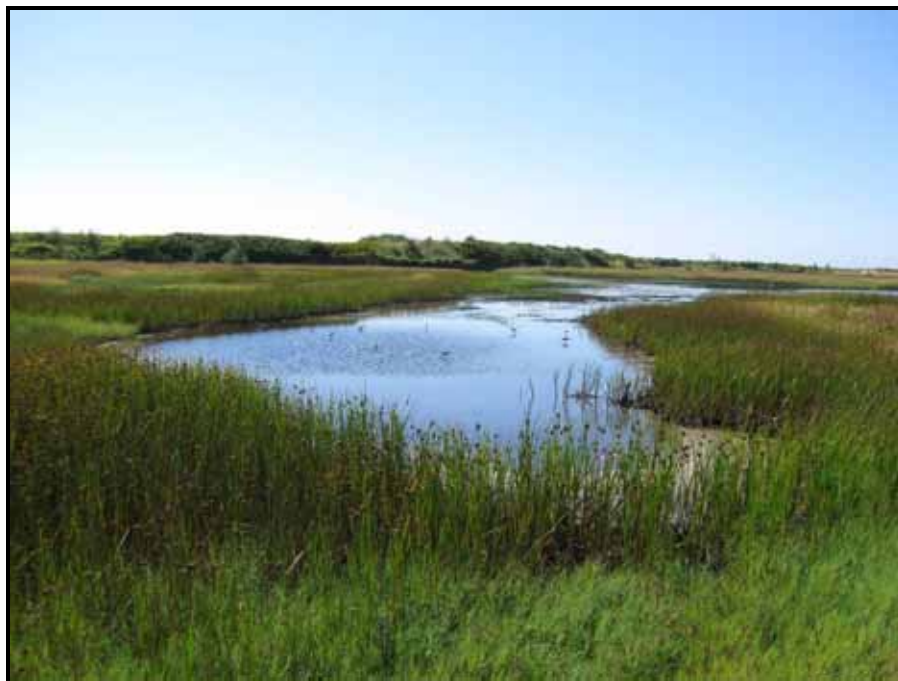
Photo 33—Shore birds foraging in flooded mud flat at half-tide
